# THE WRENCH

AMERICAN HONDA MOTOR CO., INC. • MOTORCYCLE • TECH SERVICE

VOLUME 2 • NUMBER 1 • JANUARY 1979

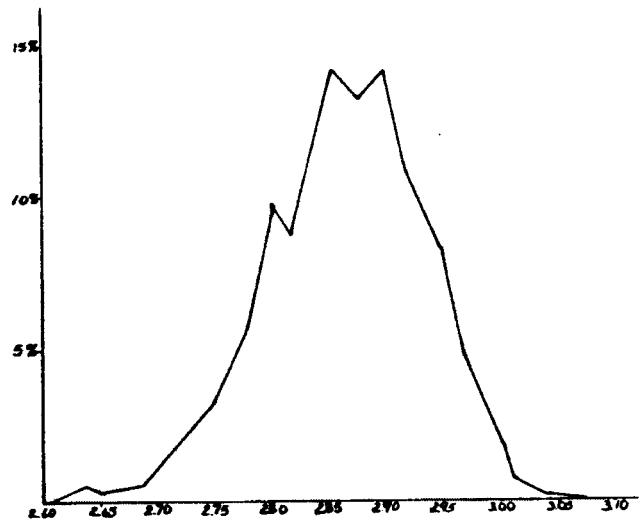
## CBX & '79 - 750 Valve Shim Sizes

The valve shims and valve lifter holder tools are the same for the CBX and the '79 - 750. Many techs have asked what shim sizes should be stocked for replacements. The above graph indicates the size of valve shims used in CBX and '79 - 750 assembly at the factory. As you can see, shims at 2.60mm to 3.10mm cover roughly 99% of the new engines during assembly. As these engines get miles on them, valve clearances increase until everything gets seated in. As valve clearances increase, thicker shims will be needed. It is recommended to stock shims from 2.60mm to 3.30mm. These should cover most applications.
